Architectural Uses Of Copper

*An evaluation of
stormwater pollution loads
and best management practices*

Palo Alto Regional Water Quality Control Plant

November 2000
Revision 3 • March 2006

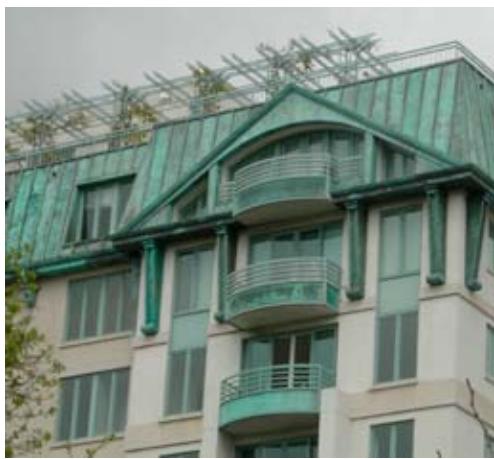
Copper roofs and flashing are fabricated into standard or custom shapes by a number of manufacturers. Roof panels (see photo at left) are commonly from 0.4 to 1.0 m (16 to 36 in) wide, and up to 3.1 m (10 ft) long, with other sizes available via special order.

Historically, copper roof panels have been soldered, overlapped, or physically seamed together. Panels today usually have formed edges that add strength and provide a simple, water-tight way of joining adjacent pieces.^[1]

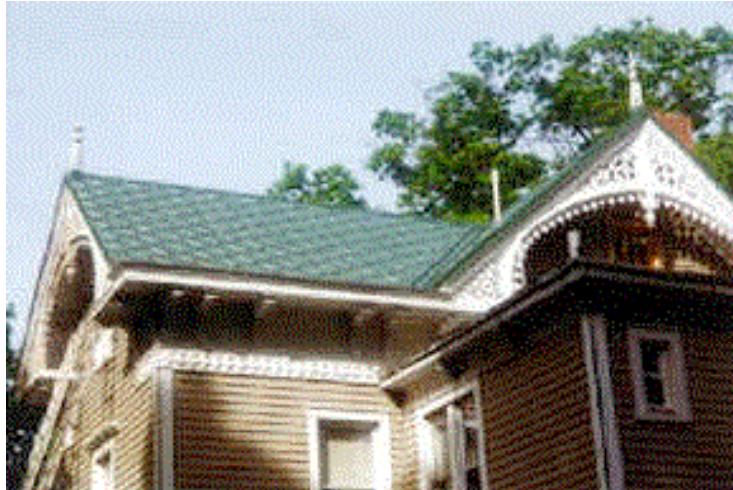
Coated steel roofing sheets, shingles (photo), and tiles are available in colors that closely match the red gold of bare copper or the light green of a copper patina. Companion features, such as gutters, downspouts, and appurtenances, are available in matching colors and textures. With proper installation, the expected life of these features should be over 100 years. ^[30]

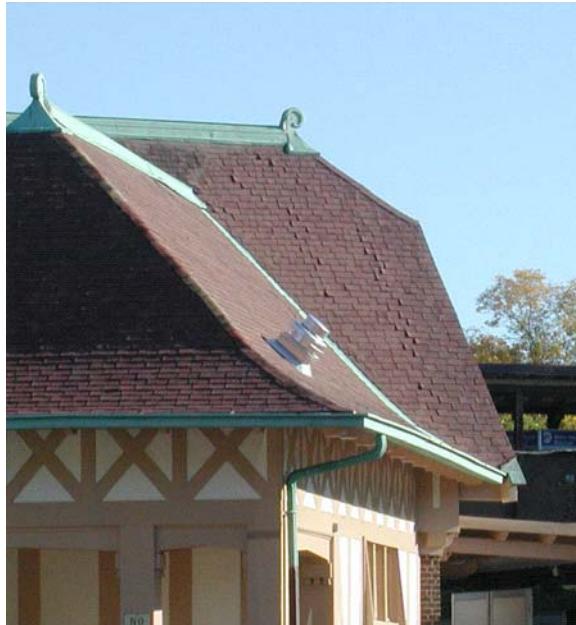
Copper is used for spires, cupolas, doors, lights, signs, railings, weather vanes and other exterior ornamental features (photo), concrete inserts, water stops, and garden edging strips. Copper releases from these small features are believed to be less significant than that from complete roofs made of copper.

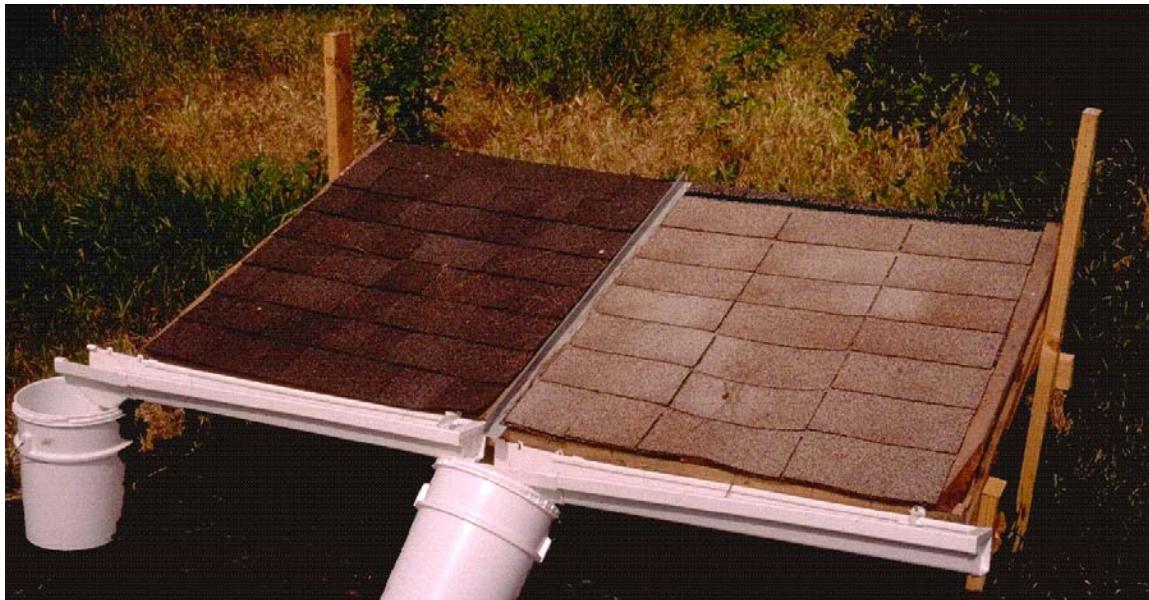
Standard and Algae-Resistant Composition Shingles

This photo shows the test stand located at the Palo Alto RWQCP that was used to measure copper in rainfall runoff. Each side of the test stand measures about 1.1 sqm. The left half of the stand is covered with standard shingles, while the right half is covered with algae-resistant shingles.
